THE PRACTICAL REFERENCE GUIDE for CORROSION OF WELDS— CAUSES AND CURES

Ted V. Weber

Principal Consultant
Weber & Associates

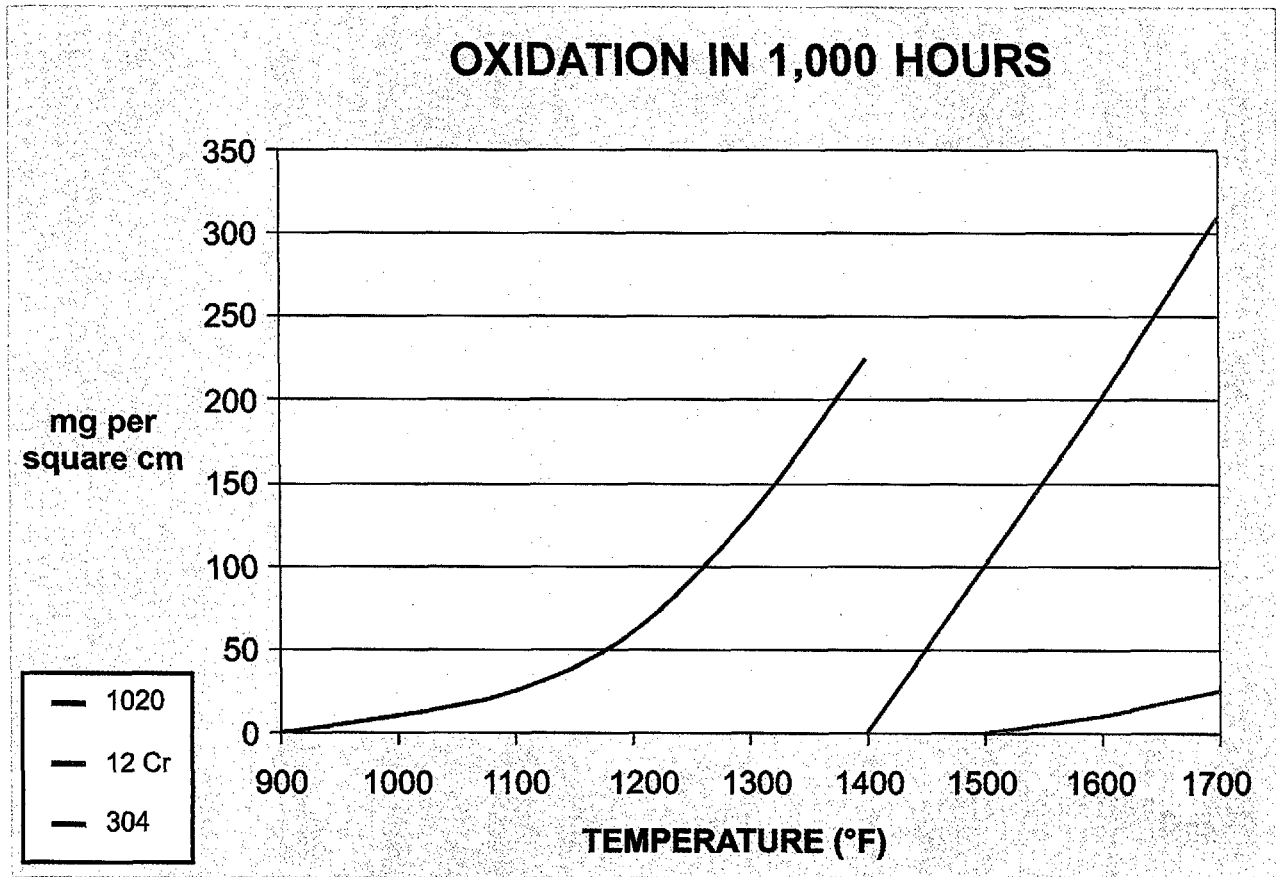
Figure 8. Curves showing weight gain in 1,000 hour hot air exposure tests for three materials. The carbon steel begins to oxidize (gain weight) at about 900°F and begins to oxidize very rapidly. The 12 Cr alloy and the 304 stainless steel have much better oxidation resistance and are useful at much higher temperatures.

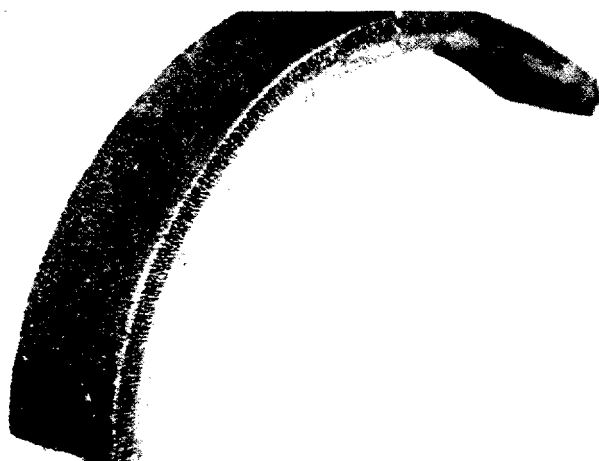
Figure 15. Exterior of sparger piping section showing severe IGA to a depth of near mid-wall. The IGA was due to improper heat treatment of the pipe.

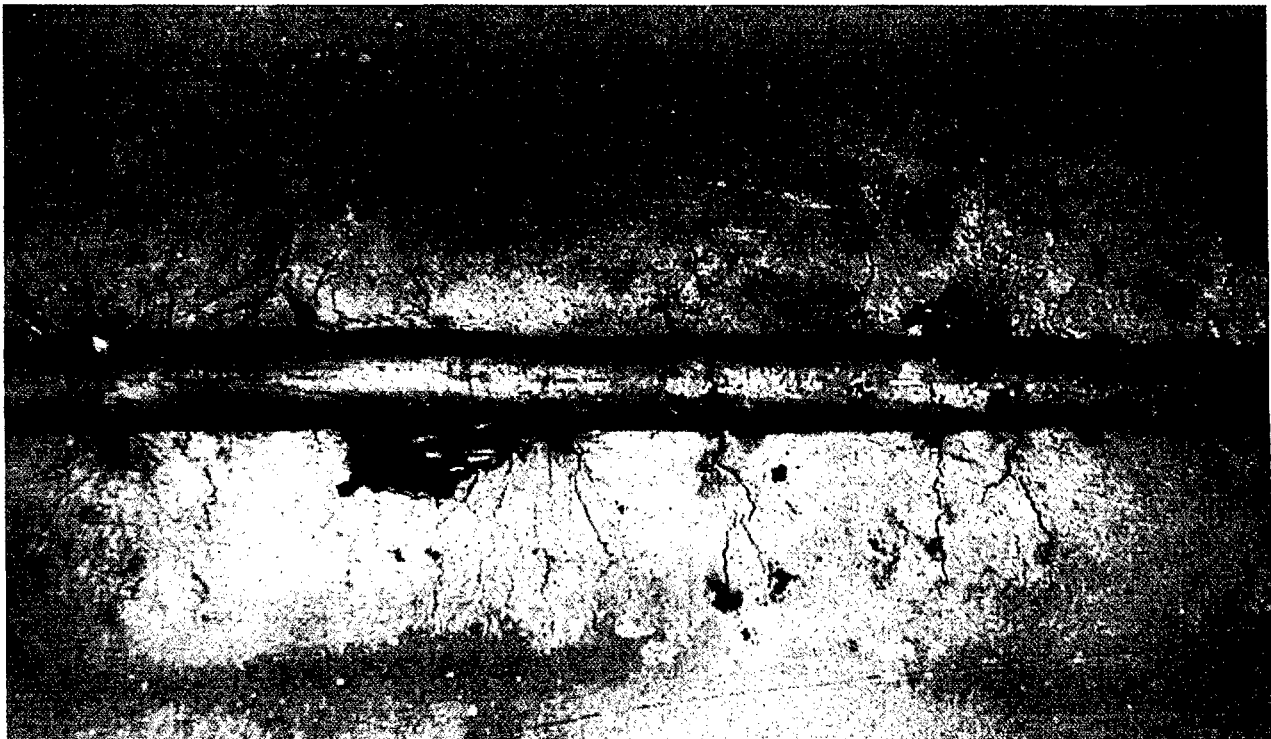
Figure 20. SCC of weld and HAZ of 317L plate butt weld by service chlorides. Note corrosion pitting of the weld and parent plate.

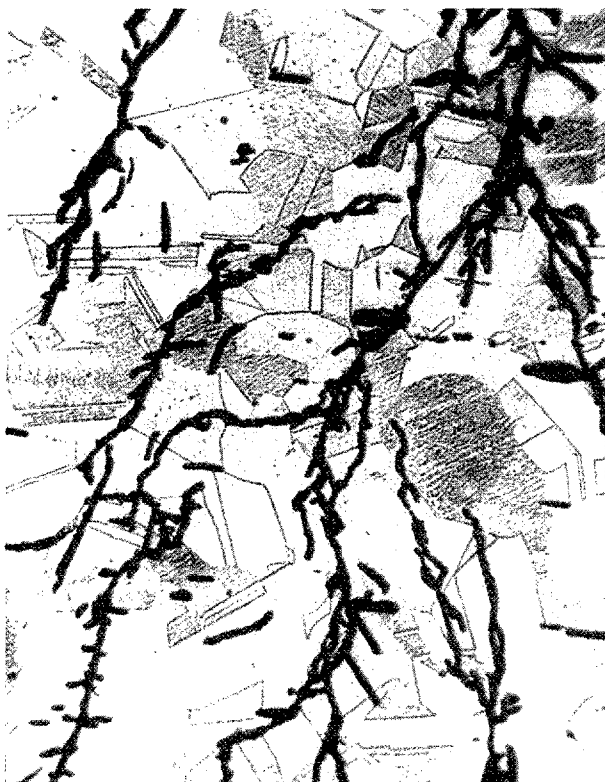
Figure 21. Photomicrograph at 400x magnification showing typical transgranular, branched, cracking of 304 stainless steel in a hot chloride environment.

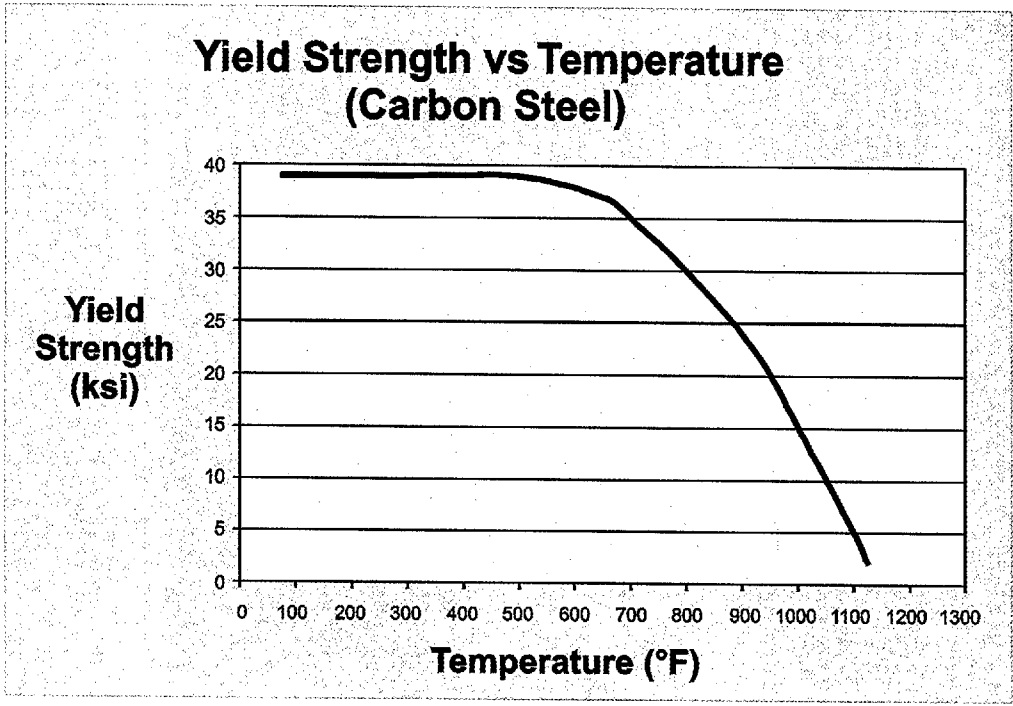
Figure 22. Yield strength of plain carbon steel versus temperature.

Figure 22 shows the approximate yield strength of a plain carbon steel in ksi versus temperature. There is very little yield strength reduction up to about 650°F, but above that, the yield strength begins to fall quickly. A typical stress relief temperature for

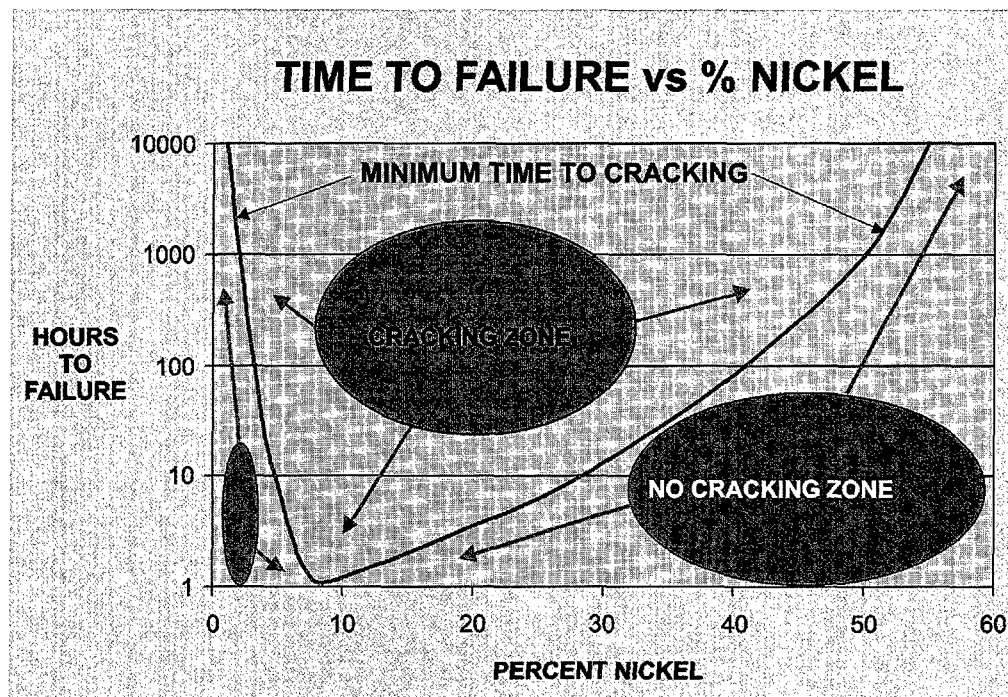
Figure 24. Time to failure versus percent nickel in hot chloride environment.

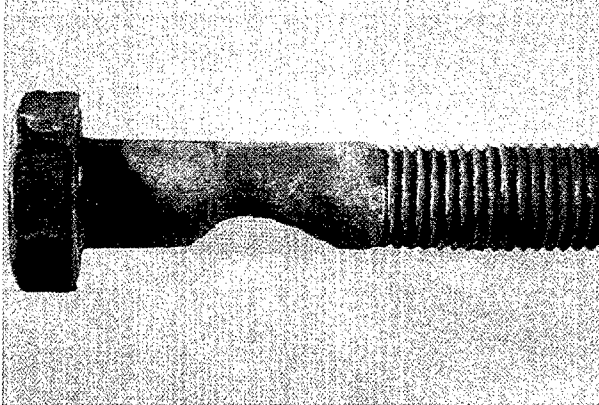
Figure 28. Shank of bolt showing crevice corrosion of shank at area of bolt where it was in contact with a flange and gasket.

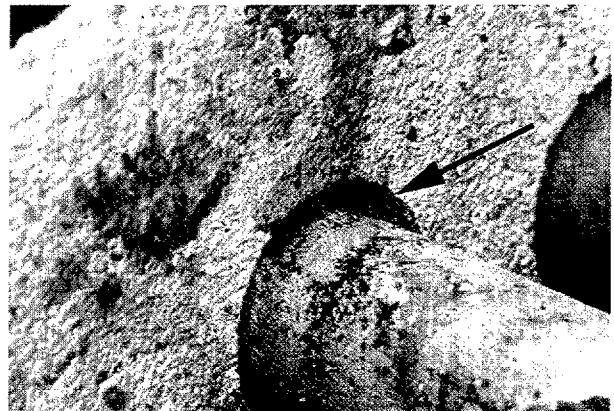
Figure 31. Back side of a carbon steel tube sheet of a shell and tube heat exchanger showing crevice corrosion of tubesheet at tubesheet hole.

liquid. Areas beneath the flange or gasket often contain different concentrations of metal ions or oxygen than the open surfaces. These differences can lead to selective corrosion adjacent to or beneath the crevice formed. Additionally, surface scales or surface debris on metals can also create concentration cells leading to crevice corrosion. Crevice corrosion can also occur when metals are in direct contact creating a tight crevice between them (see Figure 31).

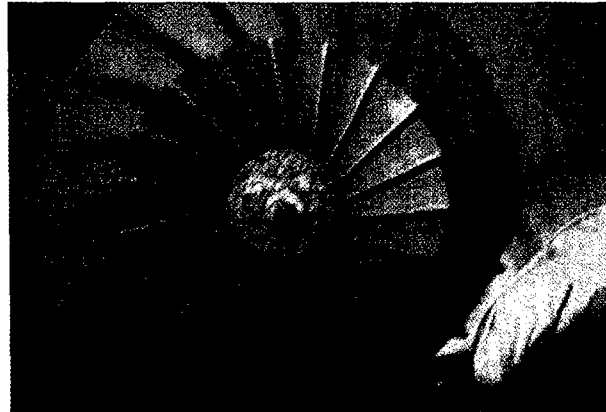
Figure 33. Titanium impeller with 410 stainless steel washer and retainer nut. Note corrosion of 410 sst due to galvanic corrosion; the titanium was protected.

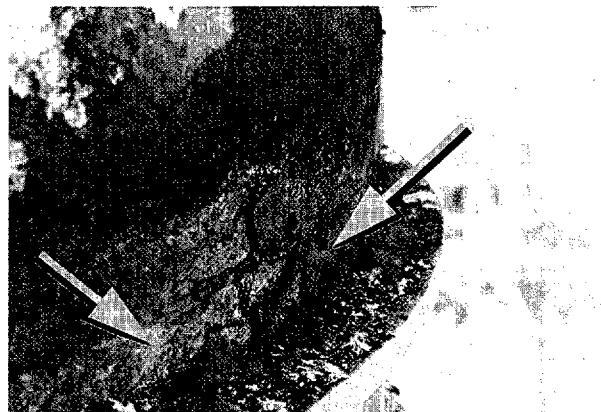
Figure 44. Close-up of Figure 43 column exterior just above encircling support ring showing severe scaling and corrosion of carbon steel at the right arrow. The “silver colored” metal beneath the scale at the left arrow is the interior nickel lining.
